# Manhole Inspection Summary

Manhole # S27A1\_005MH

**Location** Address: **Cedley st**

Cross Street: **Manokin st**

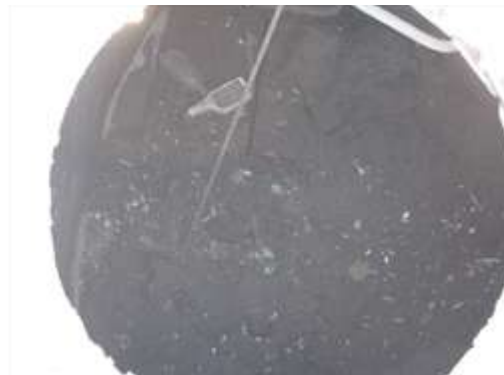
Top View

Comments **MH 005 is abandoned, MH has heavy mud diposits , was unable to get pipe measurements due to pipe diposits**

heavy mud deposits in MH, is covered in deposits

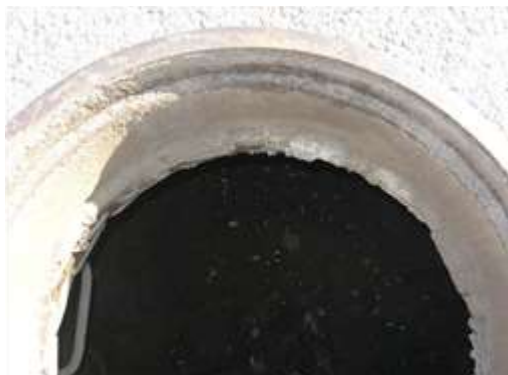
Defect 5

Offset: **5** (in.)

5 Inches Offset

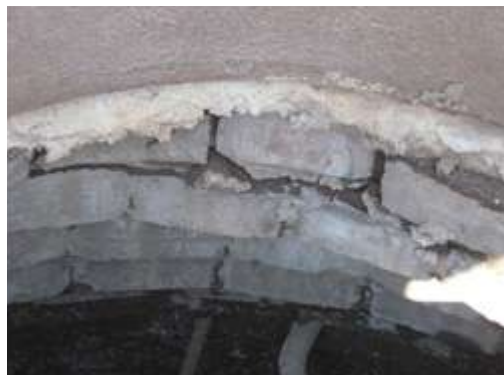
Defect 4

Infiltration: ☐ None ☐ Joint ☐ Cracks ☒ Mortar ☐ Roots ☐ Wall

Photo of missing mortar at the chimney

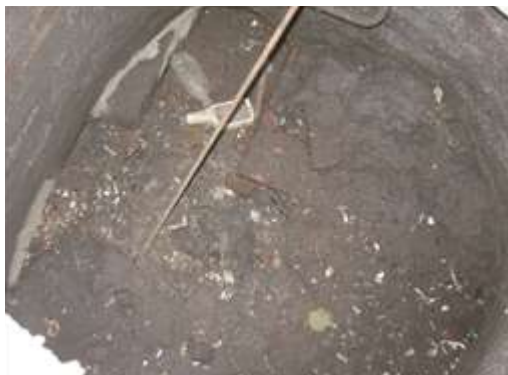
Defect 3

Condition: ☐ Sound ☐ Cracked ☐ Root Intrusion ☐ Deteriorated ☐ Leaks ☒ Debris

Heavy mud deposits in bench and channel

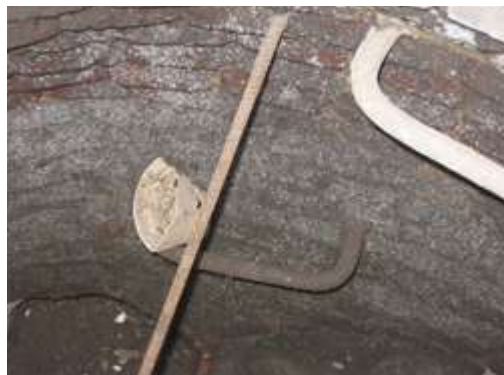
Defect 2

Infiltration: ☐ None ☐ Joint ☐ Cracks ☐ Mortar ☐ Roots ☒ Wall

Photo of barrel infiltration

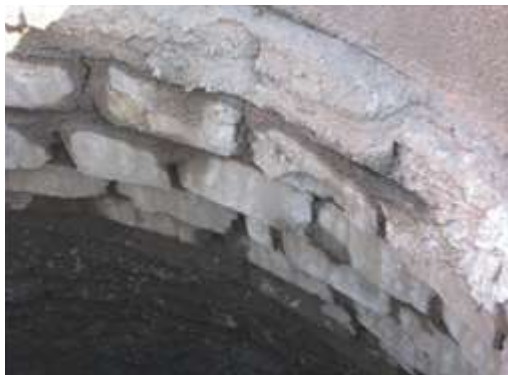
## Defect 1

Infiltration: ☐ None ☐ Joint ☐ Cracks ☐ Mortar ☐ Roots ☒ Wall

evidence of infiltration in chimney and corbel through mortar

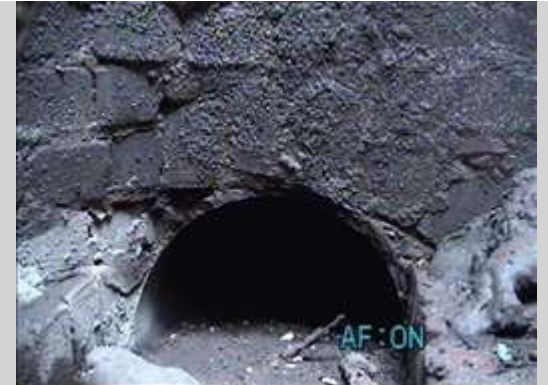
12 O'Clock Outflow

Connects To: **Stub connection / abandoned**

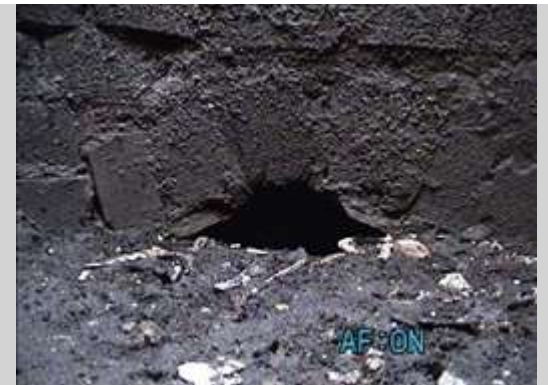
3 O'Clock Inflow

Connects To: **Stub connection / abandoned**

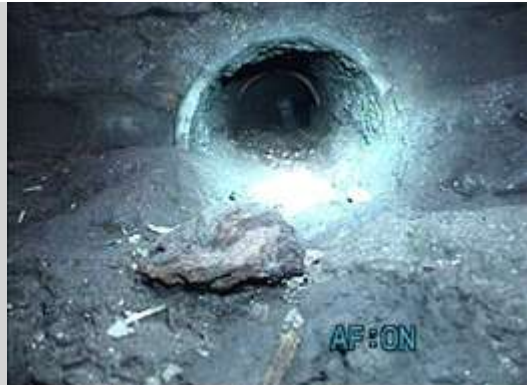
6 O'Clock Inflow

Connects To: **Stub connection / abandoned**

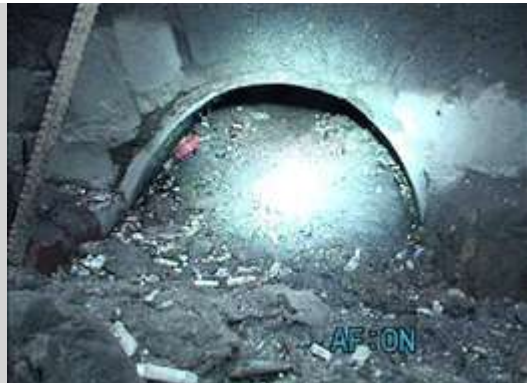
9 O'Clock Inflow

Connects To: **Stub connection / abandoned**
